# Manhole Inspection Summary

Manhole # S590\_\_006MH

Insp Date: **7/25/08 10:22 AM**

**Location** Address: **side 4623 odonnell st**

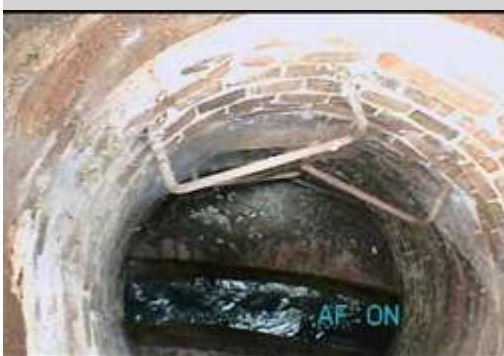
Defect 1

**Steps** Count: **4** Missing: **0** ☒ **Corroded**

steps

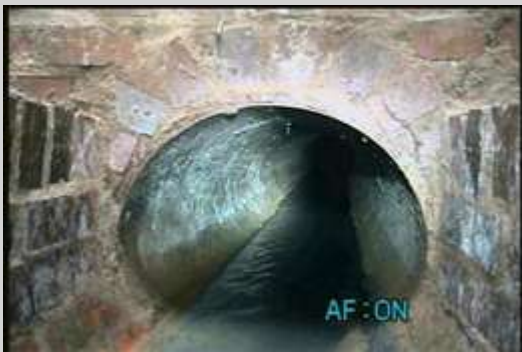
12 O'Clock Outflow

12 in. Circular Gravity Sewer  
Pipe Out @ 12 O'Clock

Pipe Material: **Clay** ☐ Pipe Lined

Invert Depth: **8.92** (ft.) Flow Characteristics: **Fast**

Deposits: ☒ None ☐ Mud ☐ Sludge ☐ Debris ☐ Grease

Infiltration: **None** Pipe Seal Cond: **Unknown**

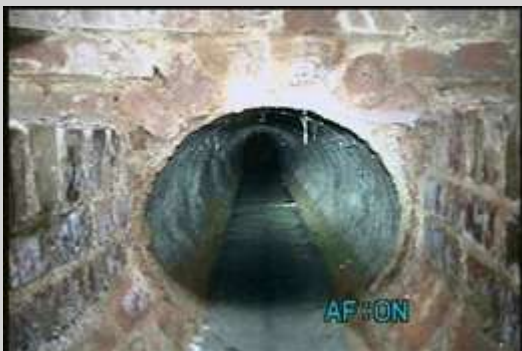
6 O'Clock Inflow

12 in. Circular Gravity Sewer  
Pipe In @ 6 O'Clock

Pipe Material: **Clay** ☐ Pipe Lined

Invert Depth: **8.83** (ft.) Flow Characteristics: **Fast**

Deposits: ☒ None ☐ Mud ☐ Sludge ☐ Debris ☐ Grease

Infiltration: **None** Pipe Seal Cond: **Unknown**
